Model: See models affected	Jan. 3, 2018
Serial #: N/A	
Product Bulletin # PDC-016

Top Drive Control Power Modification in Driller Cabin

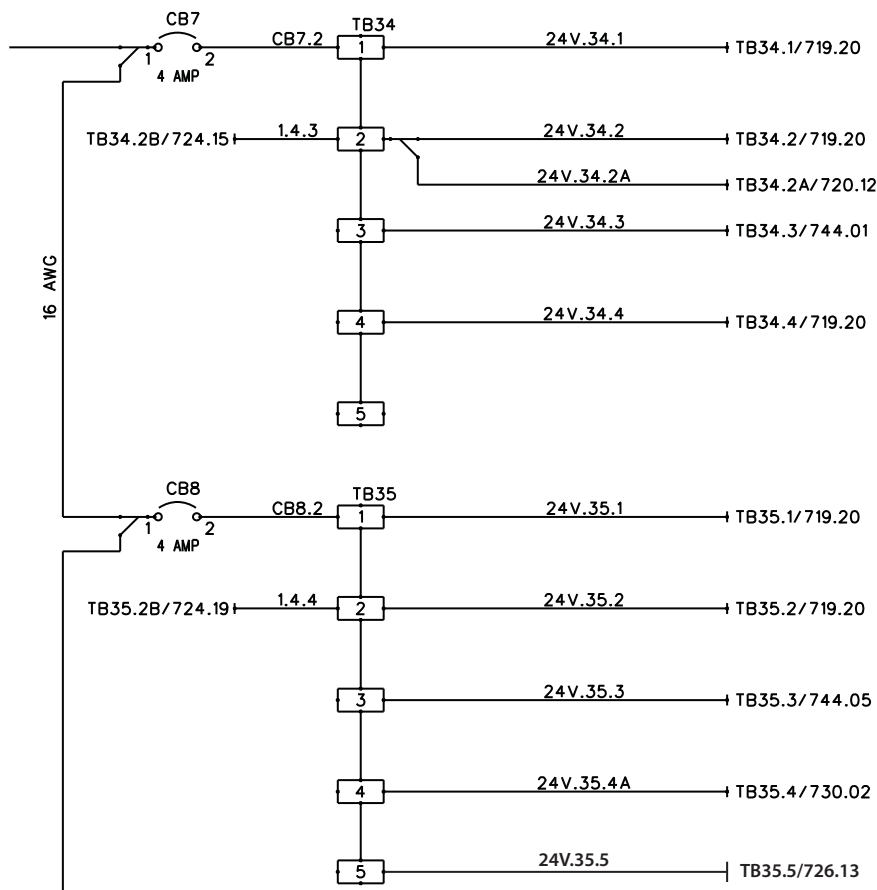
Figure 1: Wiring Before Changes on CB7 and TB34. Current Rig 1202.

Some PACE-X rigs may lose top drive control power as a result of circuit breaker 7 (CB7) tripping. This condition is caused by overcurrent on the circuit after installing the oil quality sensor.

- Note that the 4 A circuit breaker 8 (CB8) will be replaced by an 8 A breaker.
- All wires not related to top drive control power will be moved from TB35 and placed on TB34 terminal strip.
- All wires that are for top drive control power are moved and dedicated to CB8 and terminal strip TB35.
- See Figure 1 below and Figure 2 on page 3.
- See Table 1 on page 4 and Table 2 on page 5 for details.
