Product Bulletin # TDS-206 v 1.0

## Back-Up Wrench (BUW) Gripper Inspection

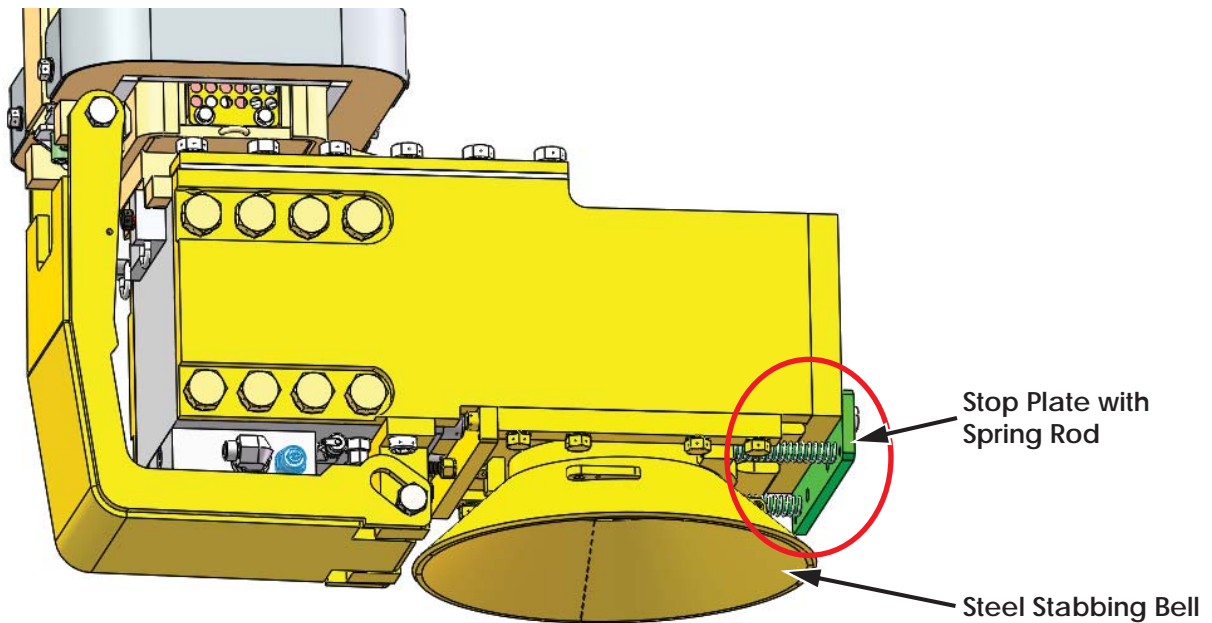
The spring rod attached to the stop plate on the Back-Up Wrench (BUW) Gripper can become detached and fall if the weld between the spring rod and stop plate fails.

Figure 1: Back-Up Wrench (BUW) Gripper

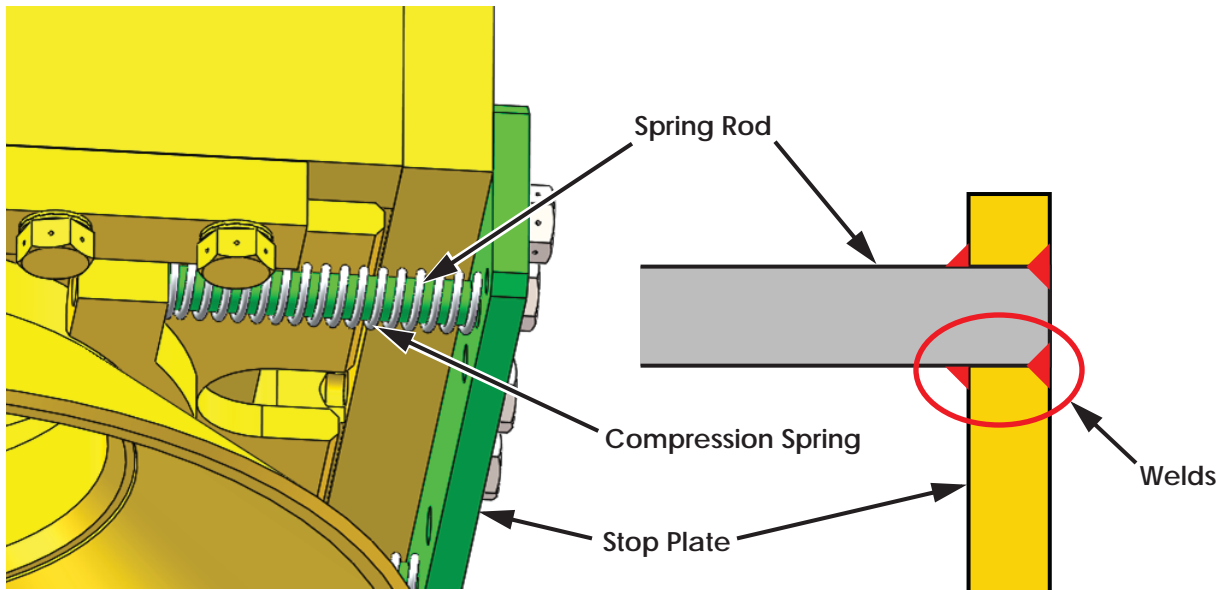
All top drives that utilize a steel stabbing bell positioned by front compression springs, see Figure 2 on page 2.

Figure 2: Spring Rod Stop Plate Weldment

- Visually inspect the weld between the spring rod and stop plate for any cracks or damage.
- Ensure the spring rod is attached to the stop plate as shown in Figure 2 below. If the spring rod or welds are damaged, then contact RIGLINE 24/7™ Support to replace the back-up wrench gripper stop plate.
- Ensure all the fasteners on the BUW gripper are torqued and secured properly with secondary retention and safety securement. Refer to the section 4A of the top drive manual for fasteners torque specification.
